# Allied-Axis

THE PHOTO JOURNAL OF THE SECOND WORLD WAR

## Karl-Gerät 040 at the front

Panzerjäger I • SdKfz. 10 1-ton halftrack  
U.S. M2 Treadway Bridge • PzKpfw. IV Ausf. A  
Type 97 Japanese medium tank

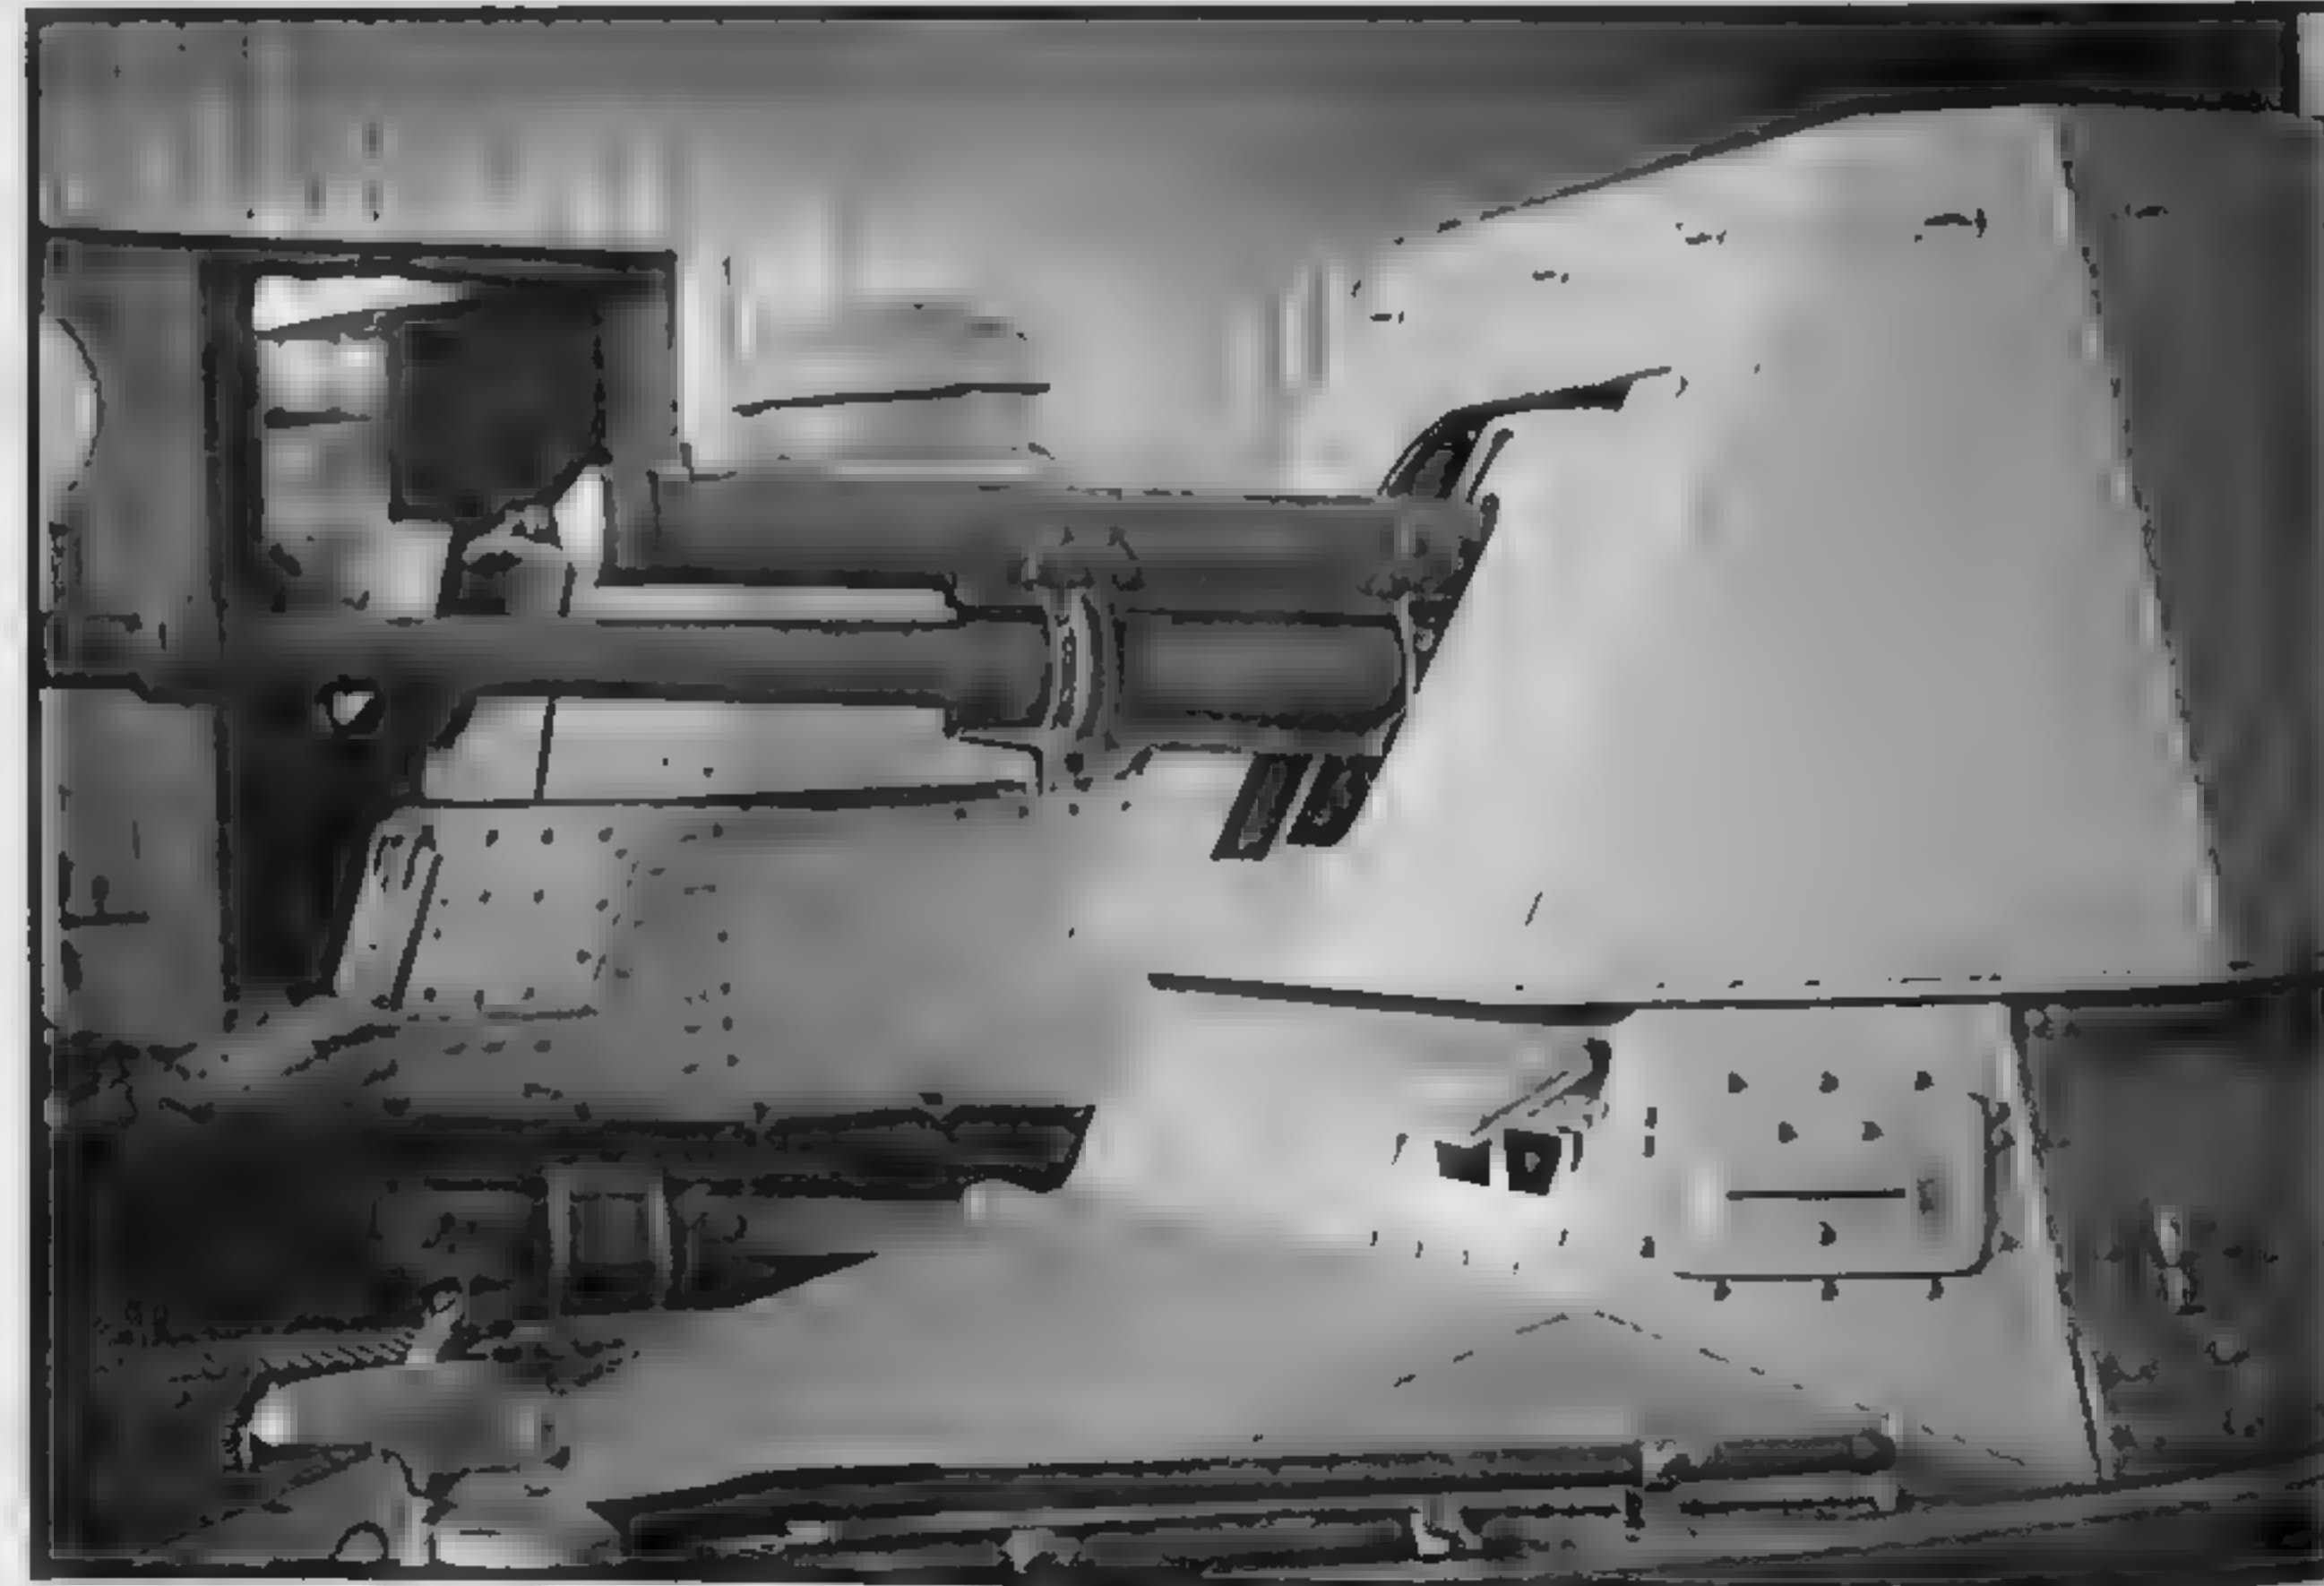
Top left, top right and left: Three views of the 4.7cm's predecessor, the 37mm KPUV vz. 34. It was fielded in three versions, horse-towed, motor-towed and the infantry version seen here. A modified version of this gun was installed in the 35(t) tank. Above right: The 4.7cm gun in its mount on the Panzerjäger I. (Parker)

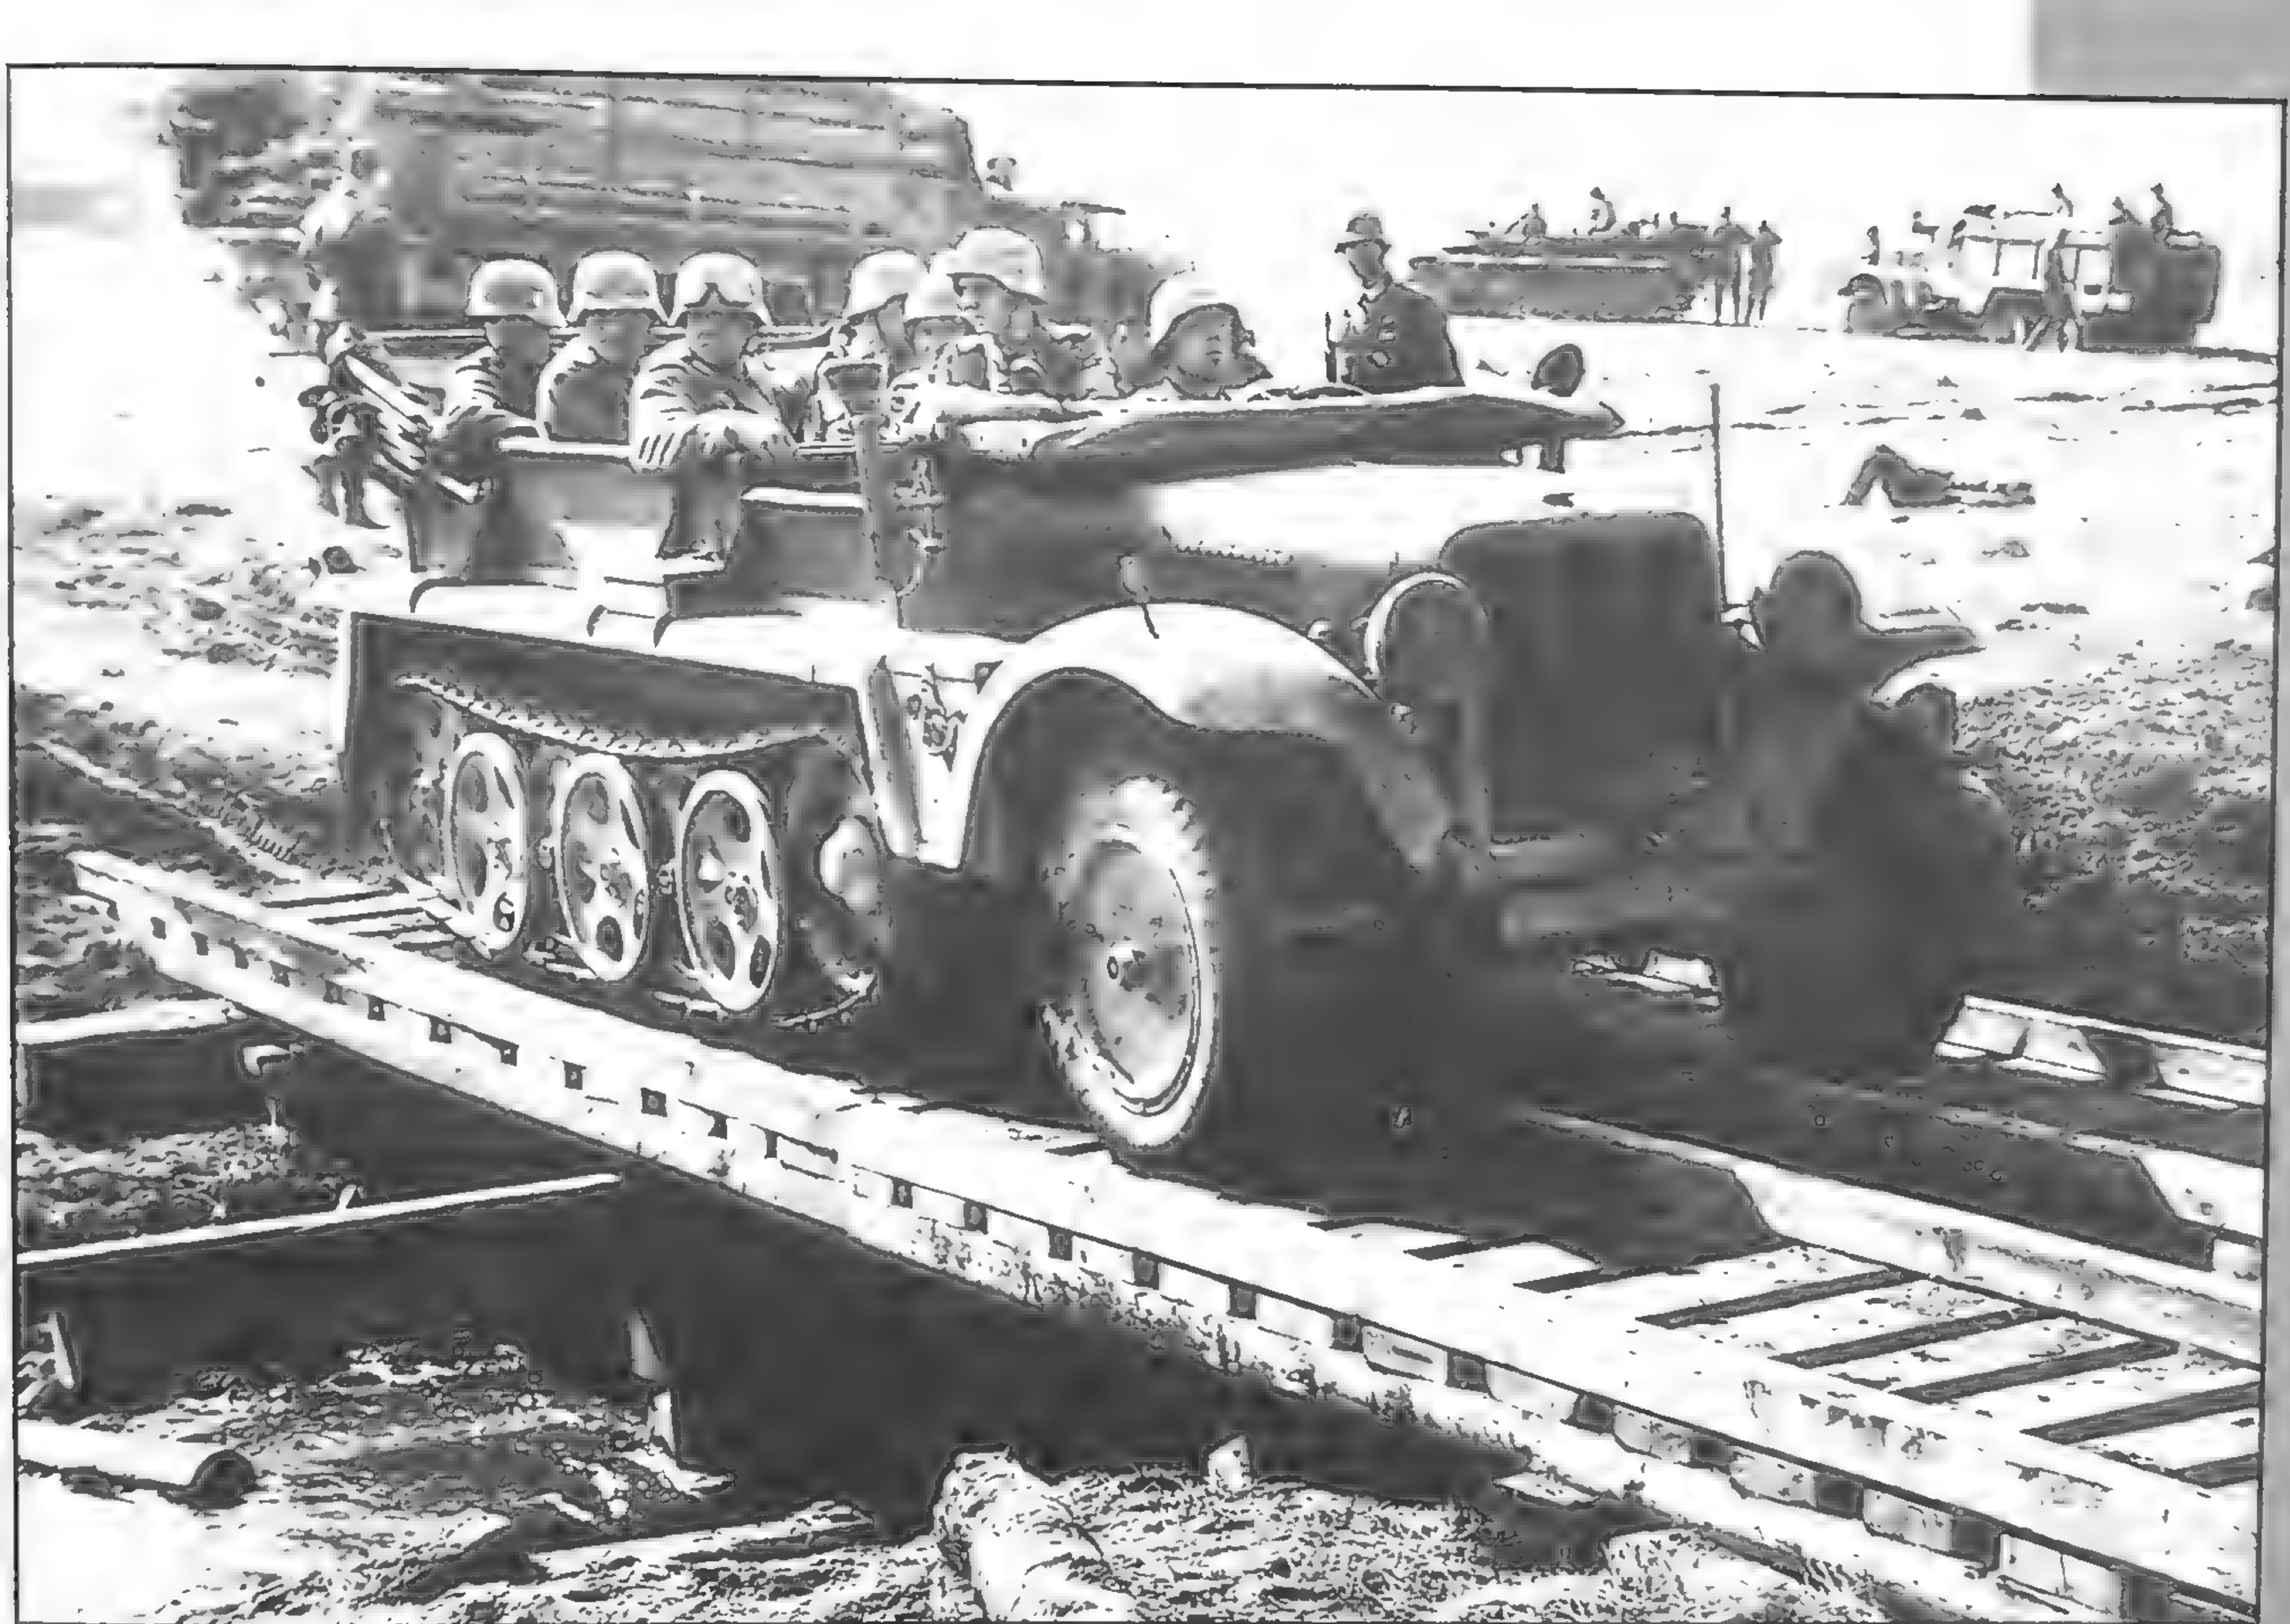
The SdKfz. 10 1-ton Halftrack was one of a number of specialized semi-tracked vehicles developed during the Second World War. Design of the SdKfz. 10 began as early as 1934, with several prototypes being tested. The vehicle utilized an air-powered front axle combined with a tracked rear axle, allowing it to travel on both roads and in deep mud. The final production version of the vehicle was powered with a Maybach HL 35 six-cylinder engine and was designated lighter

Zugkraftwagen 1t (SdKfz. 10). Initial design and production was done by Demag AG of Wetterau, but later Ader, Büssing-NAG, Mechanische Werke-Cottbus and Saurerwerke also produced parts for the vehicle. This vehicle is seen in service on the eastern front during the winter of 1943-44. To maintain the automotive performance of SdKfz. 10 was considered excellent. 33

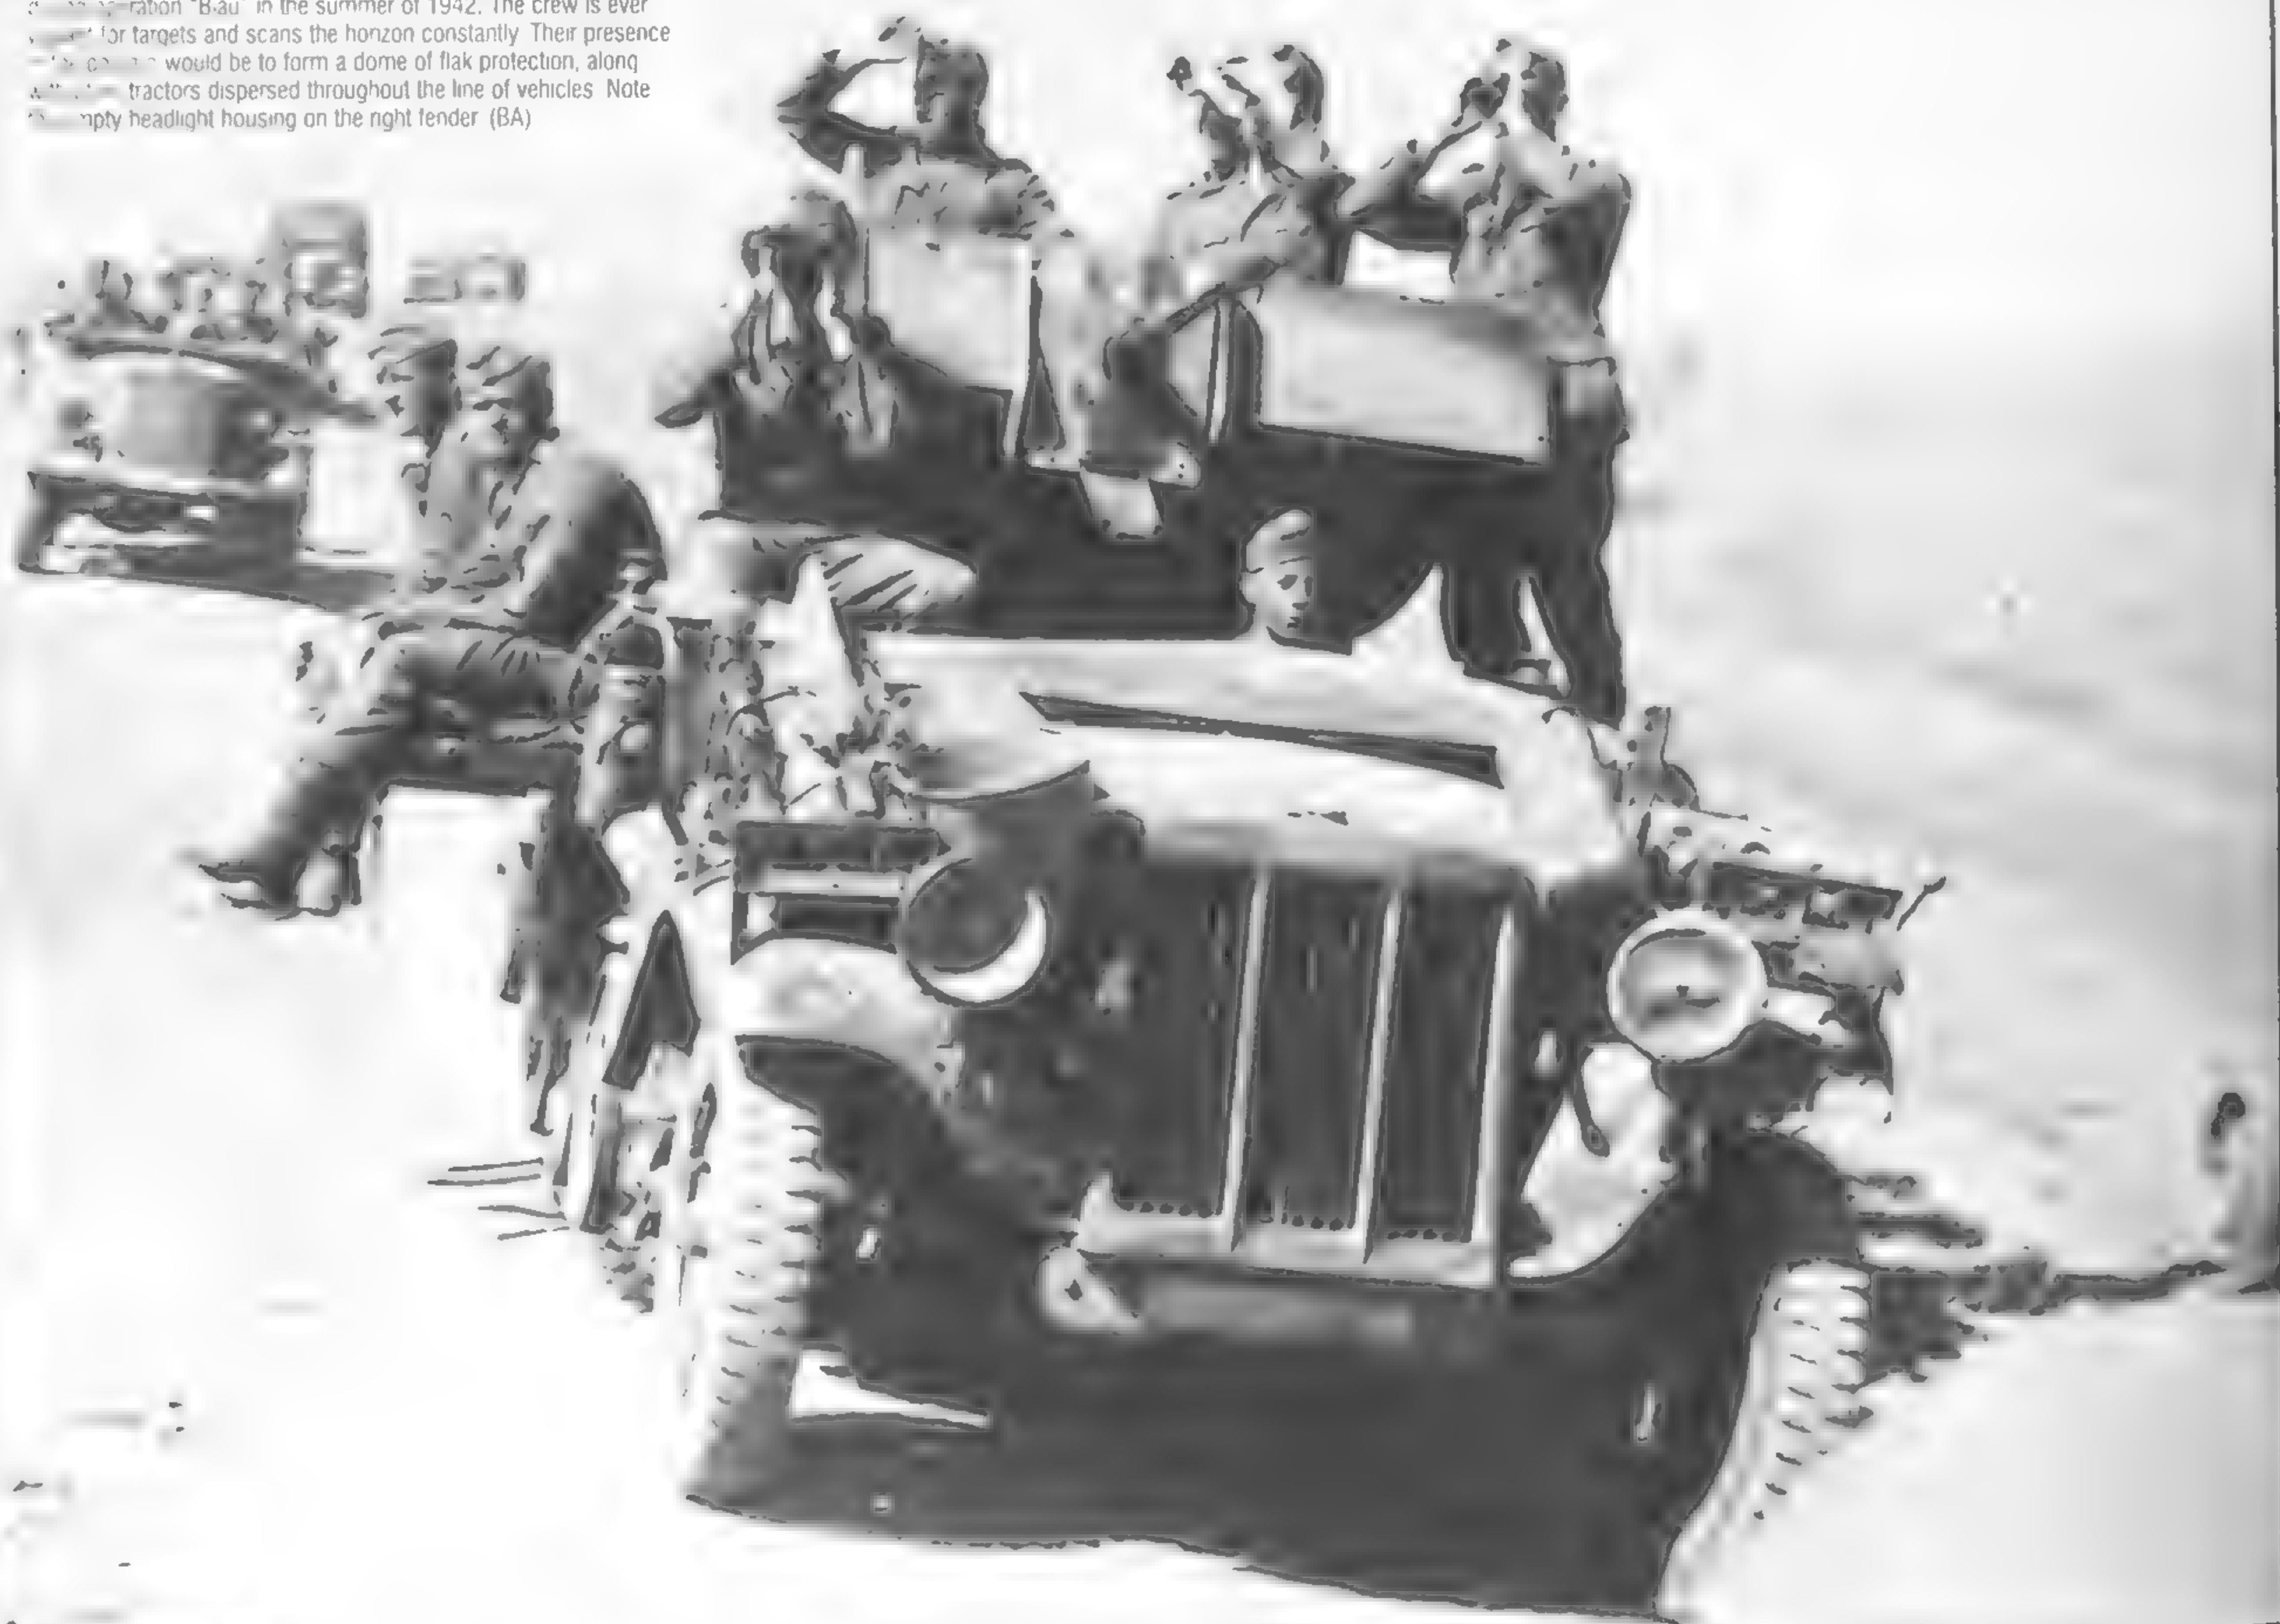
One of the primary advantages of the SdKfz 104 was the ability to quickly remove and replace the weapon. This could be accomplished on its towed mount or installed in a fixed emplacement. The SdKfz 104 generally towed a small ammunition trailer, but vehicles such as this could be used to transport ammunition in larger quantities. (BA)

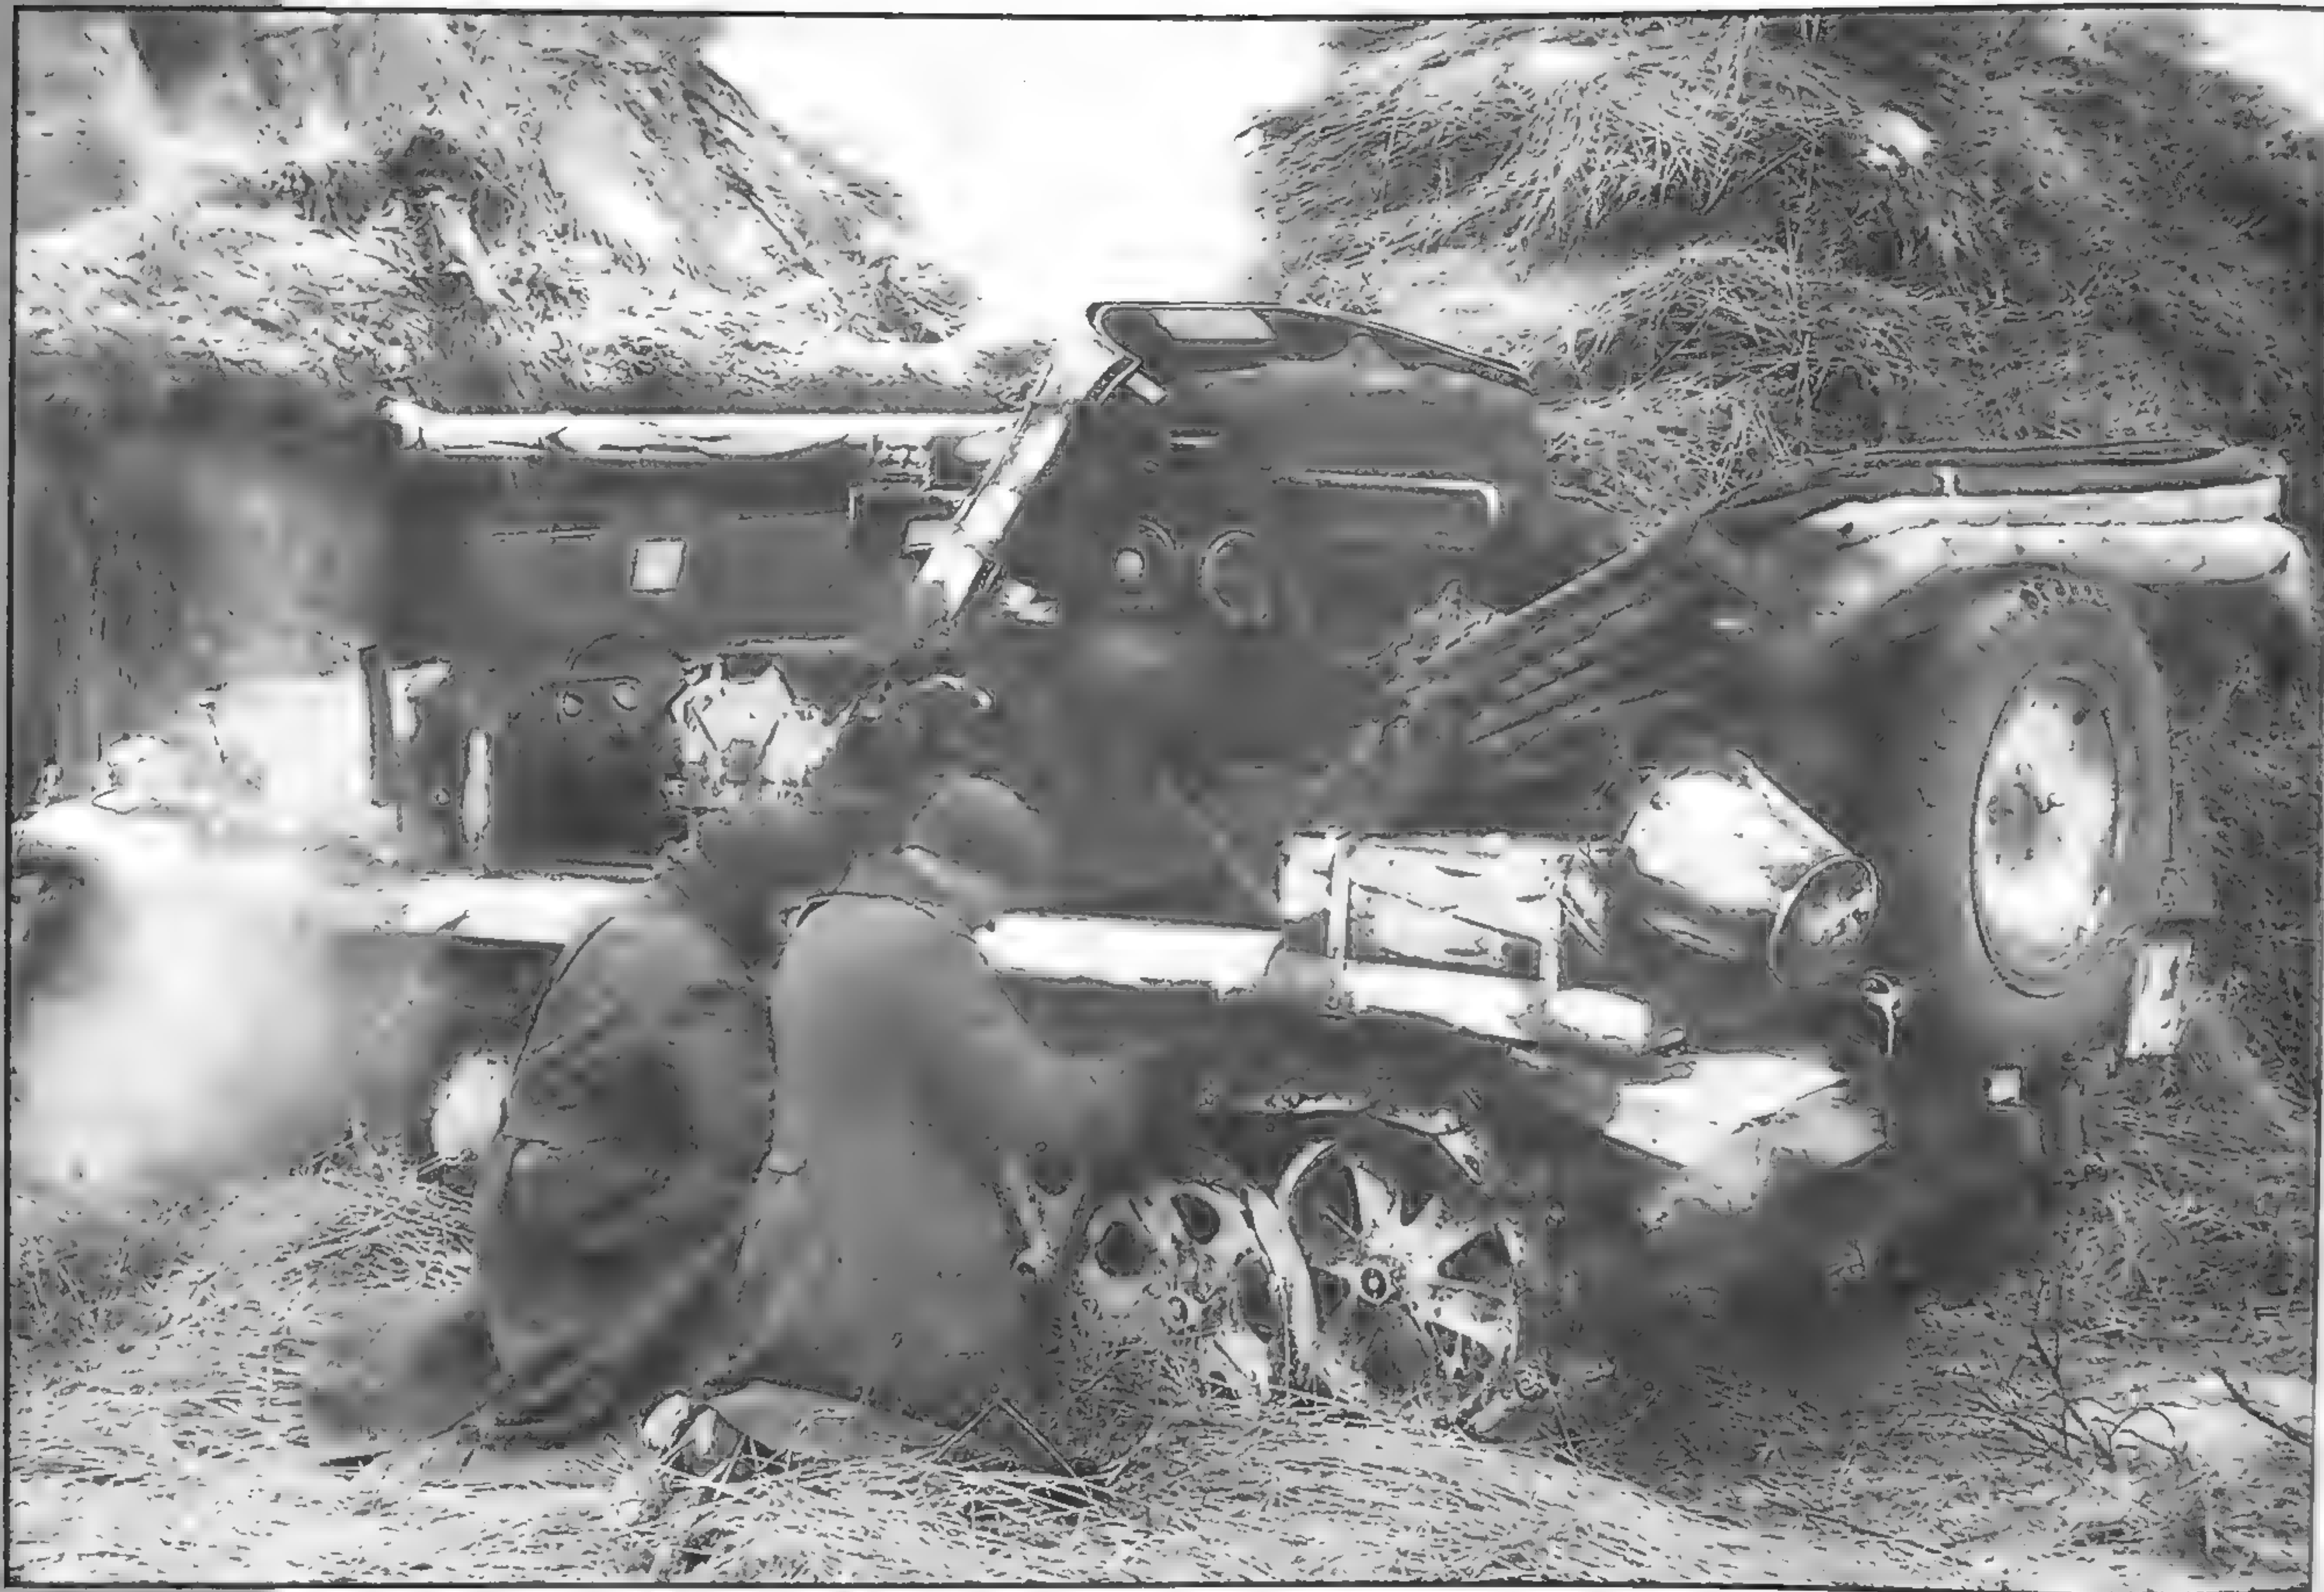
One of the most unusual uses of the SdKfz 10 was as a platform for mounting the 5cm PaK38 L60 anti-tank gun. The gun was placed on a steel crossbeam that was laid across the rear crew compartment. The gun was used complete minus its wheels and trails. Armored plate was added to the radiator housing and the windshield in a manner similar to the SdKfz 10/5. This was a unit made conversion of

the SdKfz 10 and not a true variant. It appears to have been limited to use with a Waffen SS unit. It is interesting to note that in this photo and others the entire soft top has been retained to give both the gun and the crew some protection from the elements. (BA)

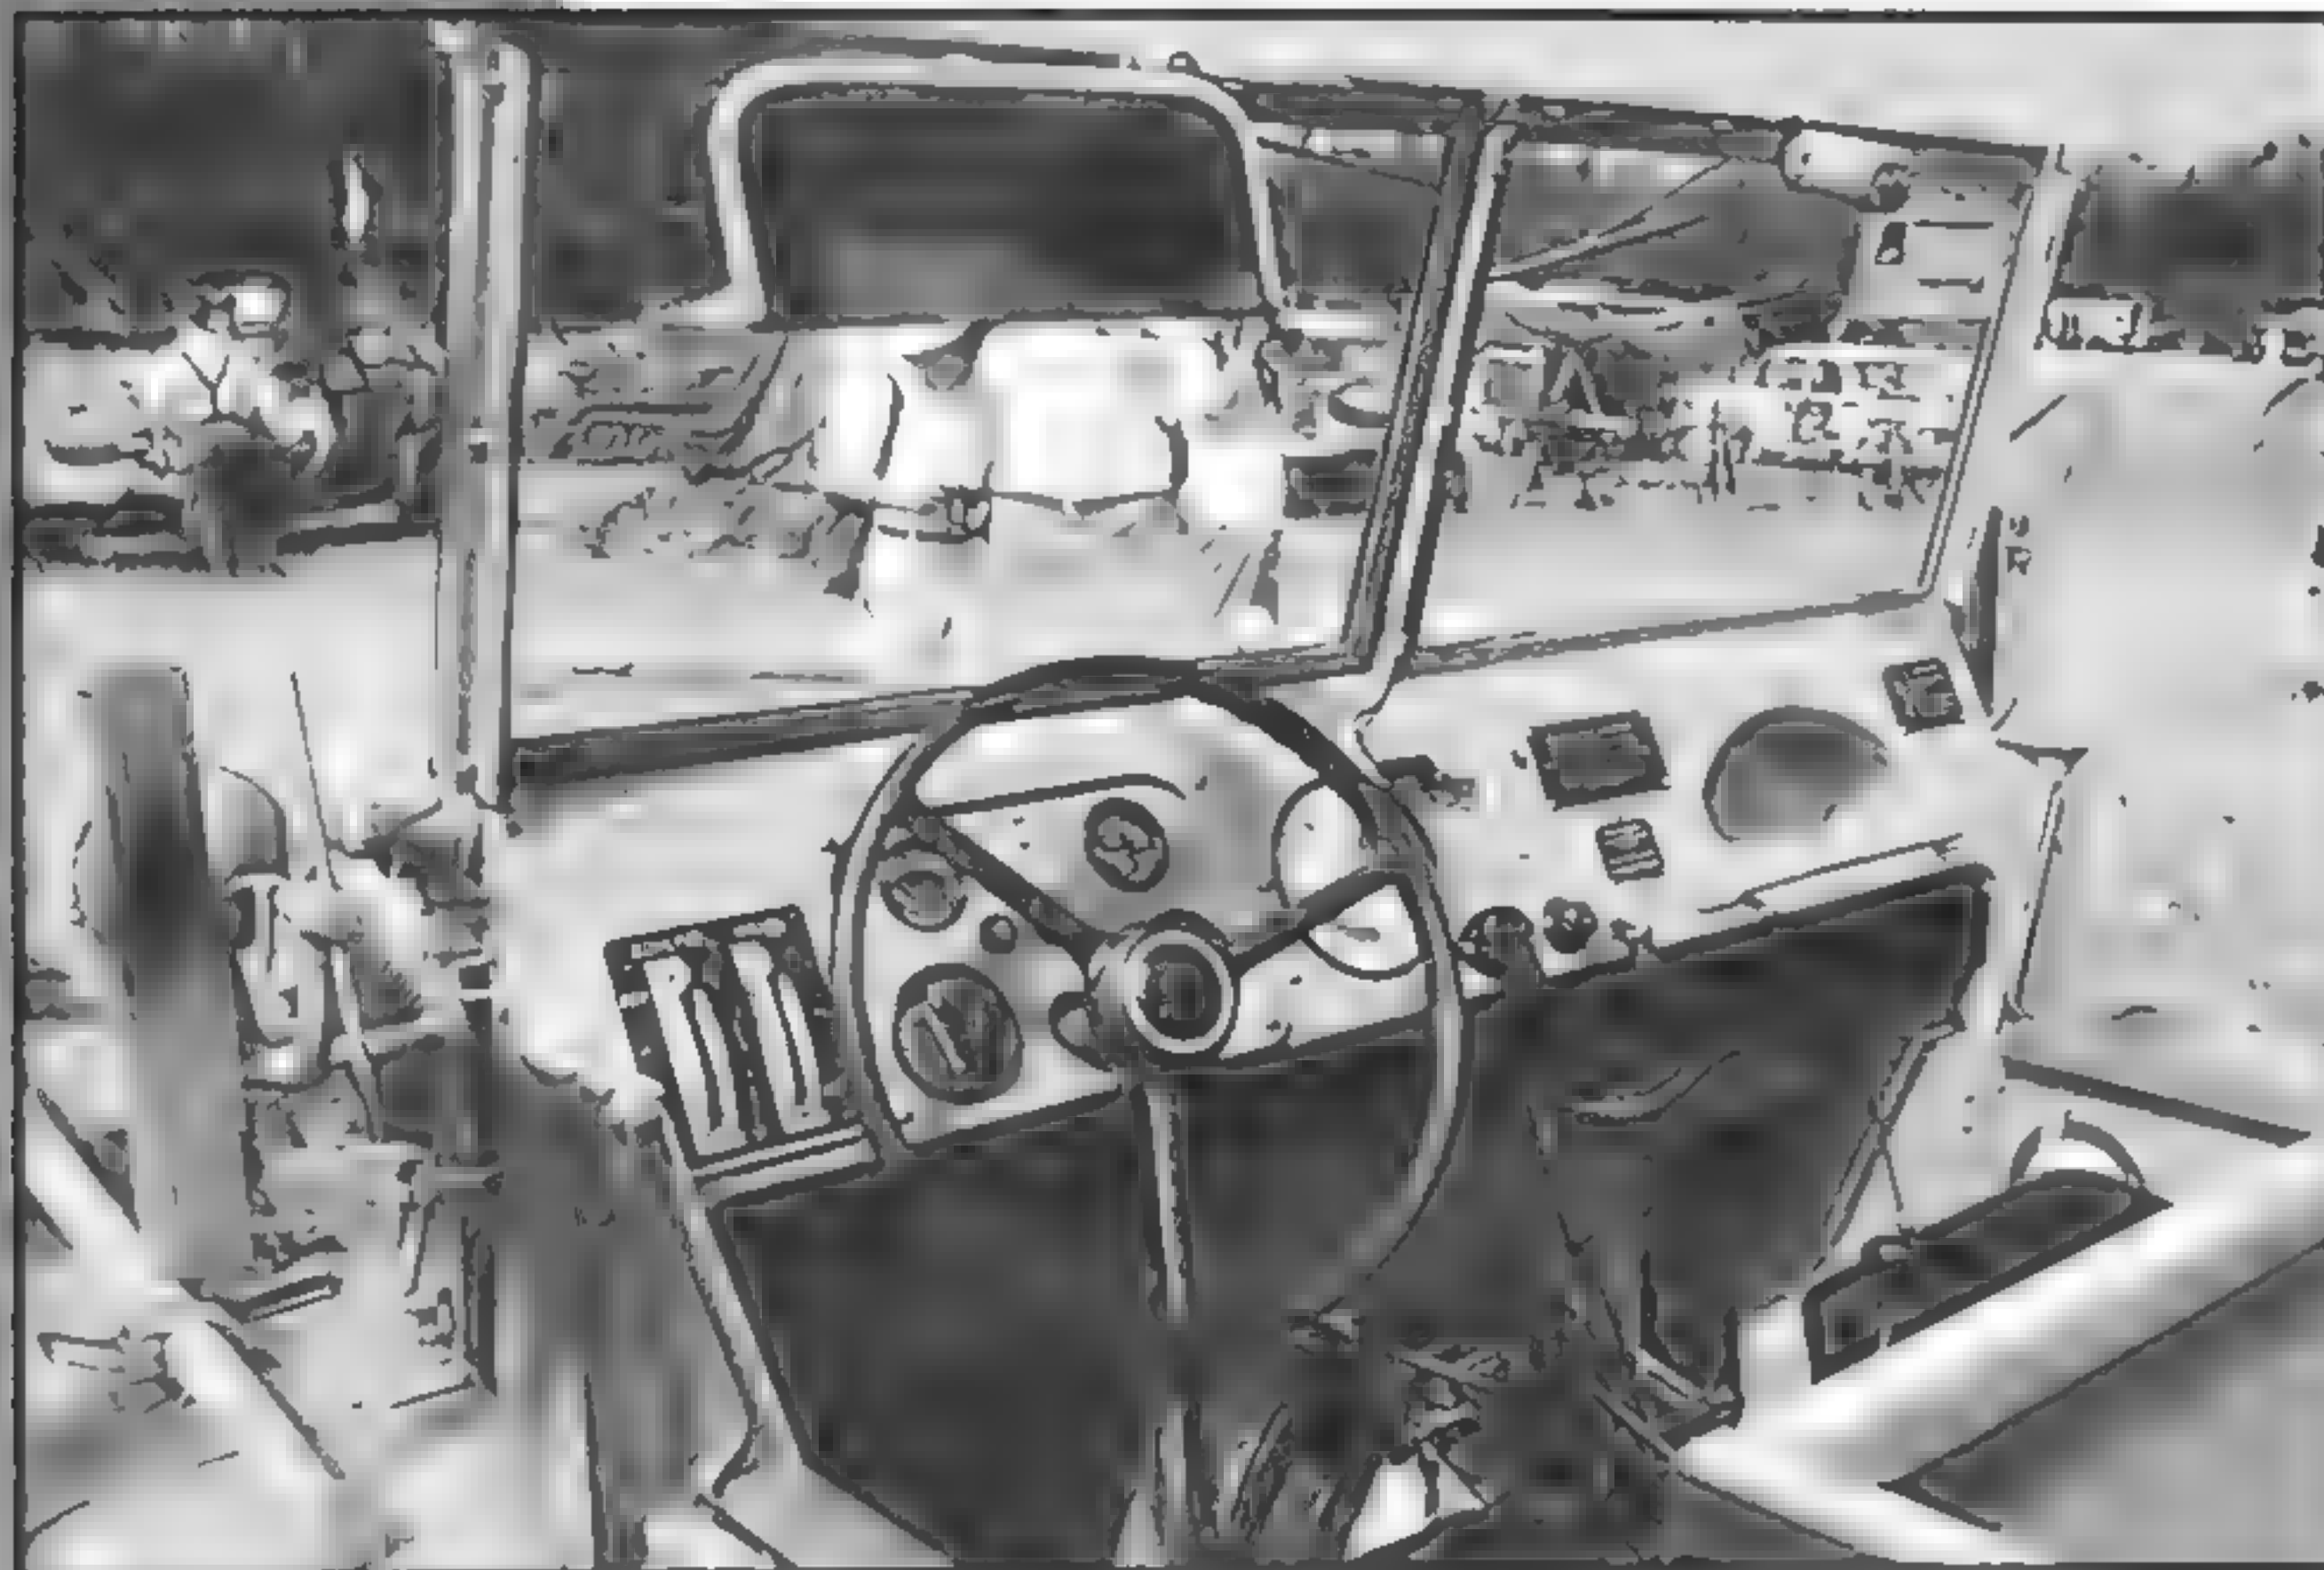
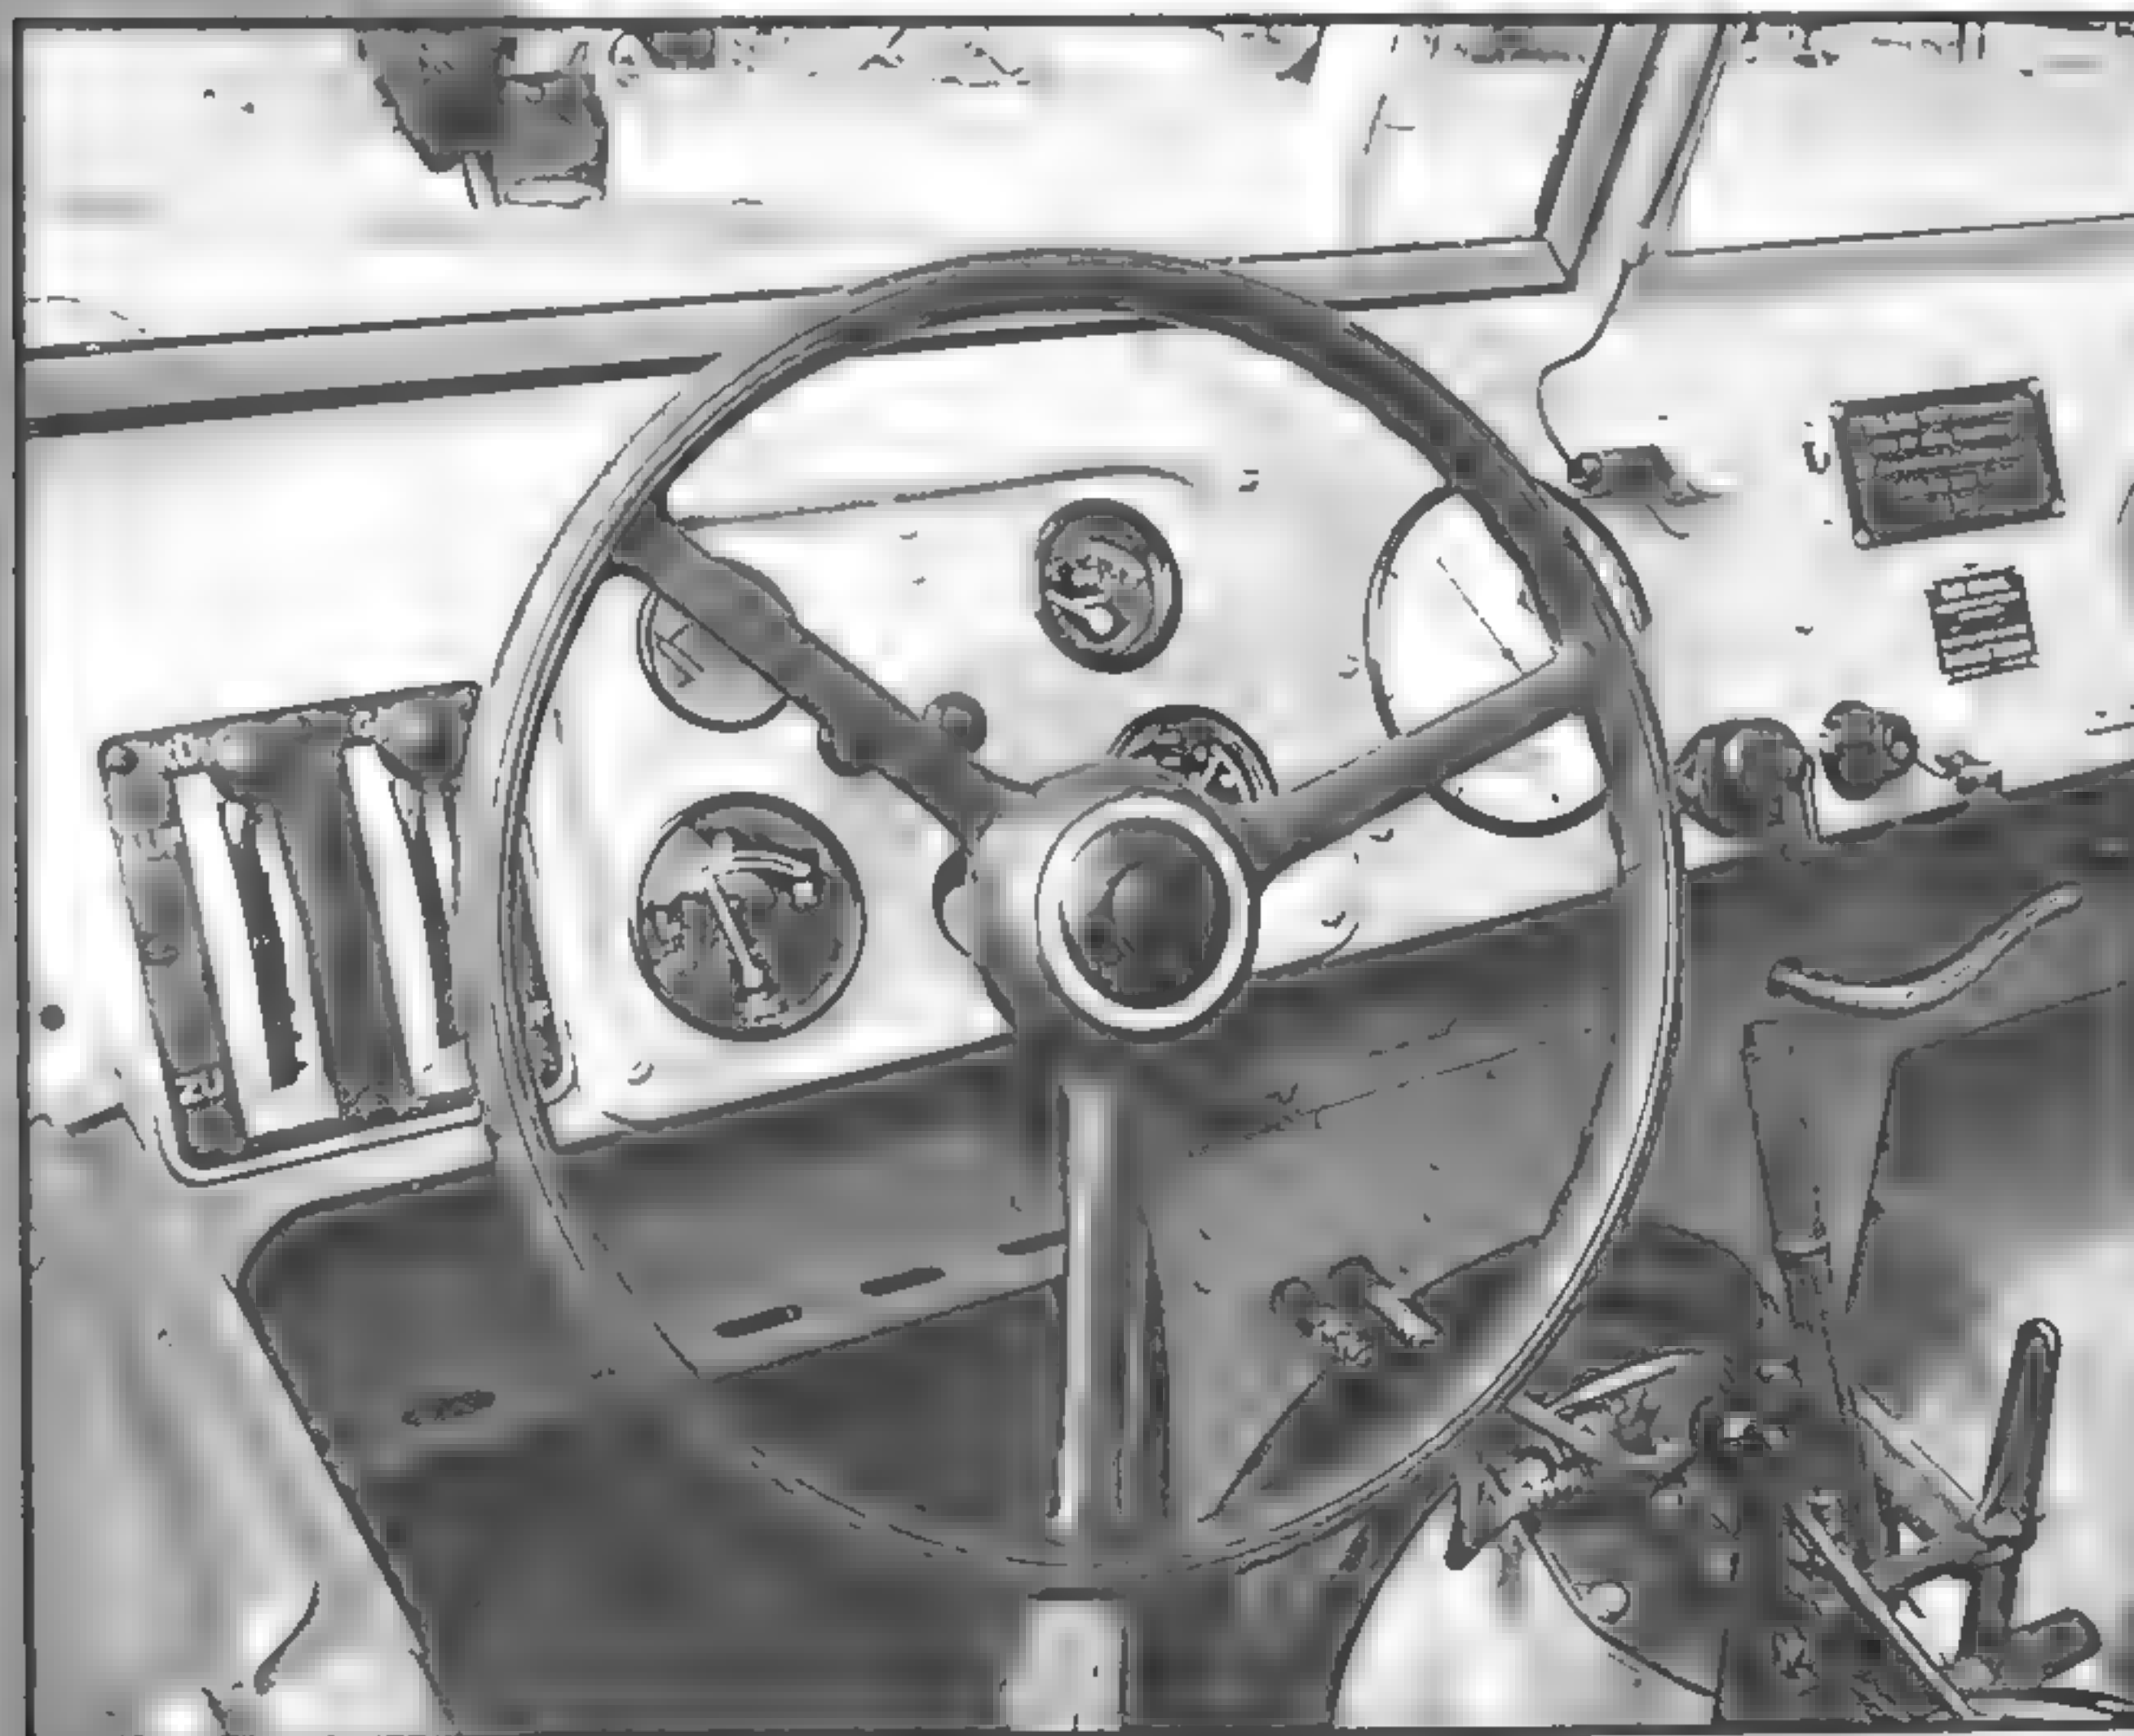
Top left and right: Two views of the front crew compartment showing the overall layout of the dashboard. Left: A close-up of the steering wheel and instrument panel. Above: A close-up of the central portion of the dashboard. The center placard reads "The track is not to be engaged while the top run is on the roadwheels, only the first roadwheel can be affected." The smaller placard reads "Do not start as long as the engine or starter is moving" and "As soon as engine starts, release starter button."
